UNITED STATES ENVIRONMENTAL PROTECTION AGENCY

Subj: Inspection Report
Clean Water Act - National Pollutant Discharge Elimination System
("NPDES")
Hull WPCF

- A. *Facility Name:* Hull WPCF
- B. *Facility Location:* 1111 Nantasket Ave
Hull, MA 02045
- C. *Facility Contacts:* Aram Varjabedian, Project Manager
Bill Boornazian, Asst Project Manager
- D. *NPDES ID No(s):* MA0101231

- A. *Date(s) of inspection:* September 18, 2019
- B. *Weather Conditions:* Mid-60s, mostly sunny (wunderground.com)
- C. *US EPA Representative(s):*
David Turin, Beth Kudarauskas
- D. *State/Local Representative(s):*
N/A
- E. *Federally Enforceable Requirements Covered During the Inspection:*
NPDES compliance under CWA Sec. 402
- F. *Previous Enforcement Actions:*
N/A

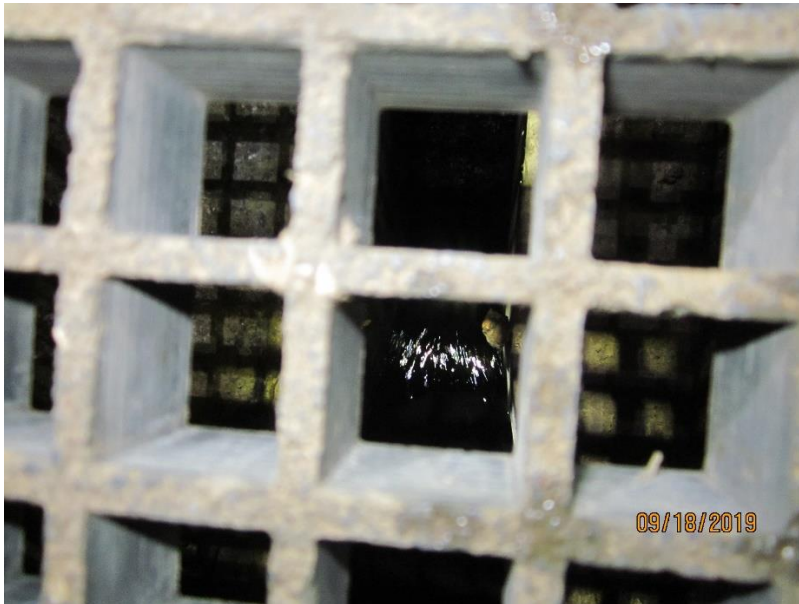
The site tour began in the headworks in the basement level of the treatment plant. The staff showed us the Parshall flume, which is covered with rubber mats to help control odors [Photo 1 and 2]. The facility explained that it relies on “strap-on” flow meters to measure influent and effluent flow at the facility via readings through the pipes, rather than the Parshall flume. Dimensions of the Parshall flume would be needed to use it for measuring flow during the field exercise. The facility explained that it uses another flow meter on the influent line between the primary distribution box and the aerators to cross-check the influent strap-on meter. Pumps and electrical control boxes are in the subbasement. The operators pointed out the influent and

Photo 1: Parshall flume at headworks

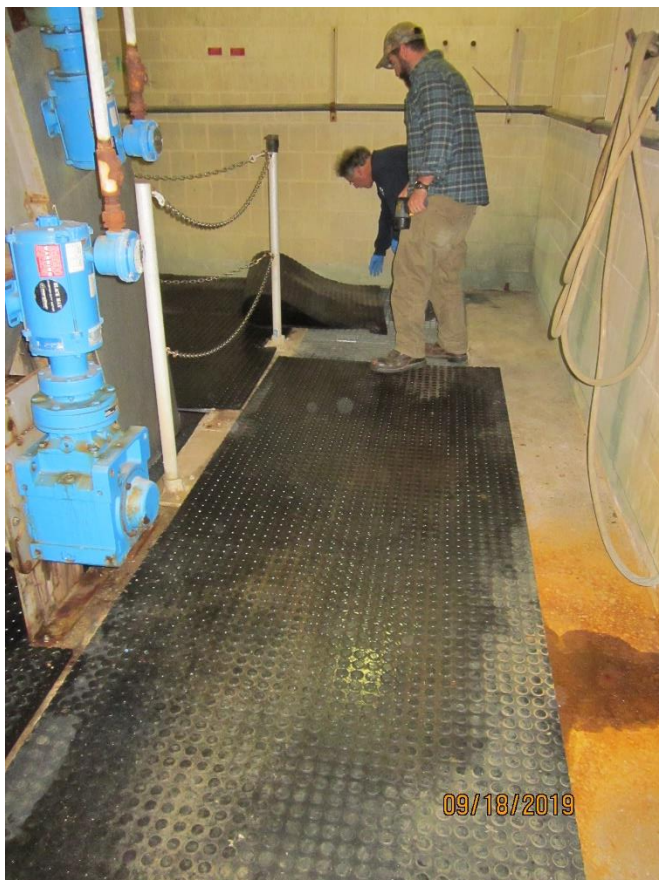
Photo 2: Rubber mat over Parshall flume

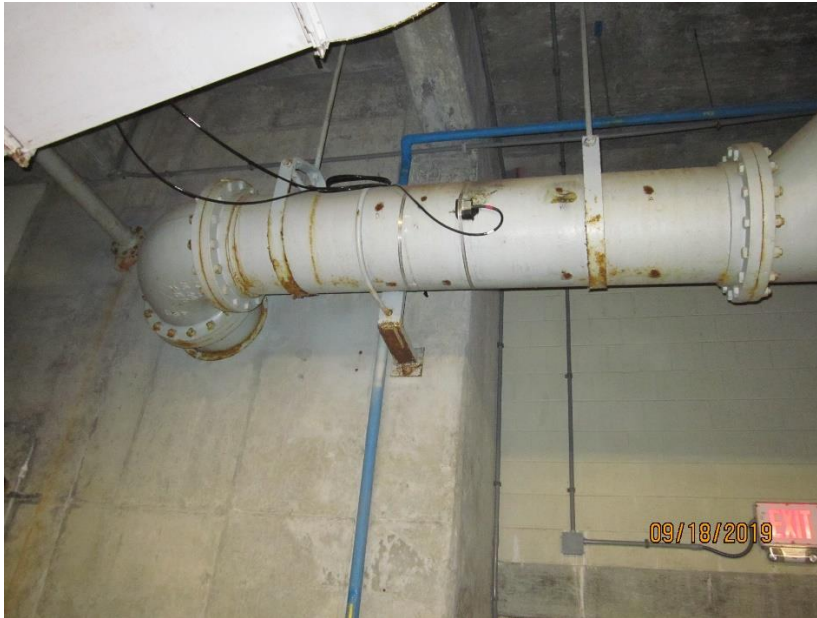
effluent strap-on flow meters [Photo 3] and indicated that while only 1 of 5 available influent pumps are needed during dry weather, all 5 may be needed to handle wet weather flow. The facility also described an influent headworks project that, among other things, would move critical electrical equipment to a higher level to protect against flooding.

Photo 3: Strap-on meters

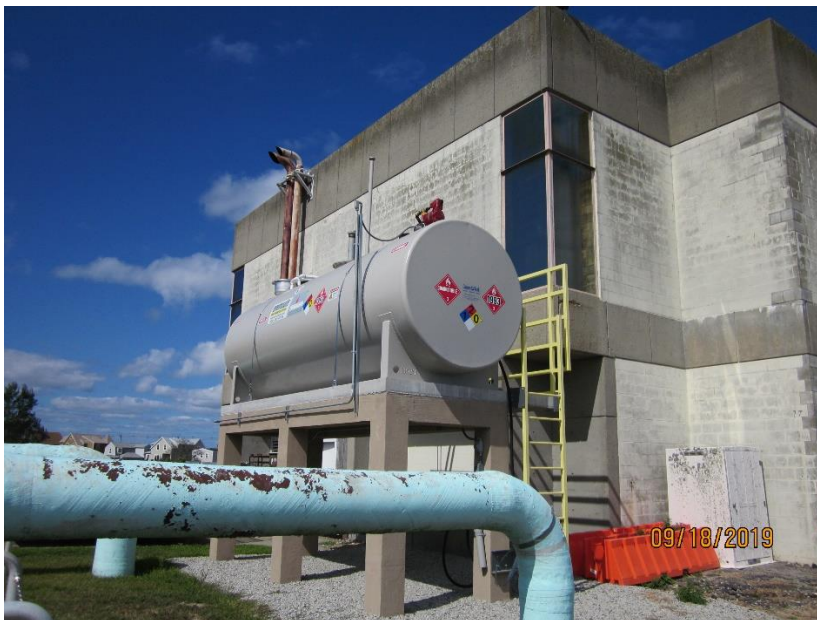
Outside the main facility building, we observed a new 3000 gallon above ground diesel fuel tank for the emergency generator [Photo 4]. We were told that the facility has an SPCC plan but did not ask to review it during this inspection. We also observed flood control gates to protect the building [Photo 5]; we were told that according to 2070 flood level projections, these gates will need to be 4' higher than they are.

Photo 4: Emergency generator fuel tank

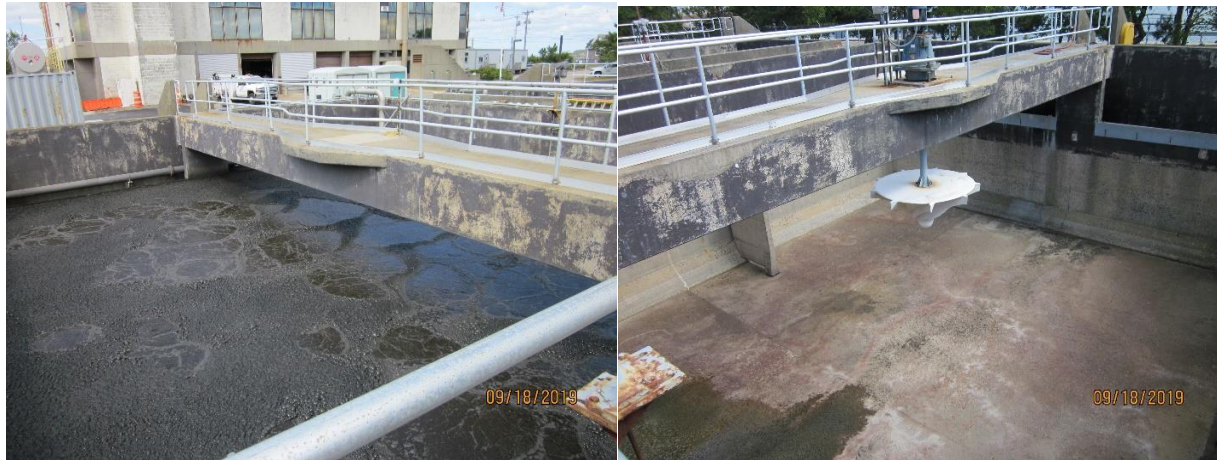
We were informed that primary clarifiers are bypassed at the splitter box and flow is diverted directly to the aeration tanks. According to the Mr. Varjabedian, this primary clarifier bypass has been in place since 2016 and the facility operates well with this configuration. The primary set of aeration tanks use diffused air. A second set of tanks that were not serviceable during a previous inspection by EPA are now reportedly available if needed and rely on mechanical mixers [Photos 5 and 6]. The operators pointed out the optical flow meter on the aeration tank influent line that they had referenced as a check of the strap-on meters, but acknowledged that this meter is not currently working properly.

Photo 5 and 6: Aeration tanks

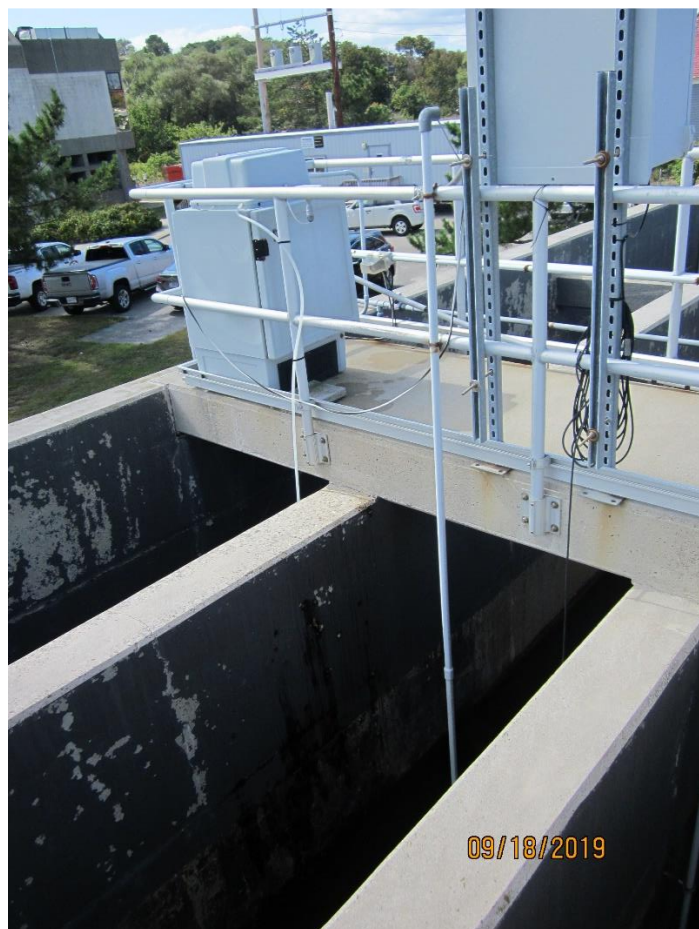
We observed the chlorine contact chamber, which is comprised of two channels that pass over weirs and recombine before entering the outfall pipe. We observed the final effluent sampling location on one of these channels [Photo 7].

Photo 7: Effluent sampling station
